Manhole Inspection Summary

Manhole # S35M__098MH

Record Plat: **35M** Node: **098** Status: **New Manhole (Not in GIS)** Insp Date: **10/15/08 12:00 AM**

Location Address: **science center**

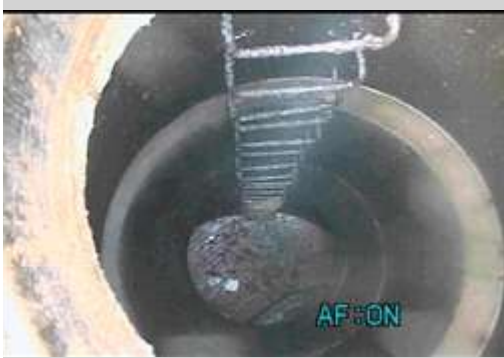
Defect 1

Steps Count: **20** Missing: **0** ☒ **Corroded**

corr steps

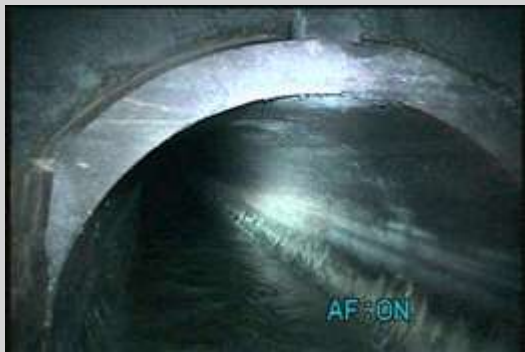
12 O'Clock Outflow

30 in. Circular Gravity Sewer
Pipe Out @ 12 O'Clock

best view channel off to the side

Invert Depth: **24.75** (ft.) Flow Characteristics: **Fast**

Infiltration: **None**

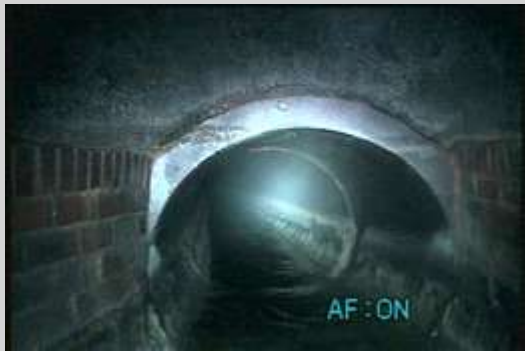
5 O'Clock Inflow

30 in. Circular Gravity Sewer
Pipe In @ 5 O'Clock

best shot channel far to the side

Invert Depth: **24.66** (ft.) Flow Characteristics: **Fast**

Infiltration: **None**
